TOWN OF MIDDLEBURY, VERMONT

SEWER SYSTEM EVALUATION STUDY – PHASE I

SEPTEMBER 2013

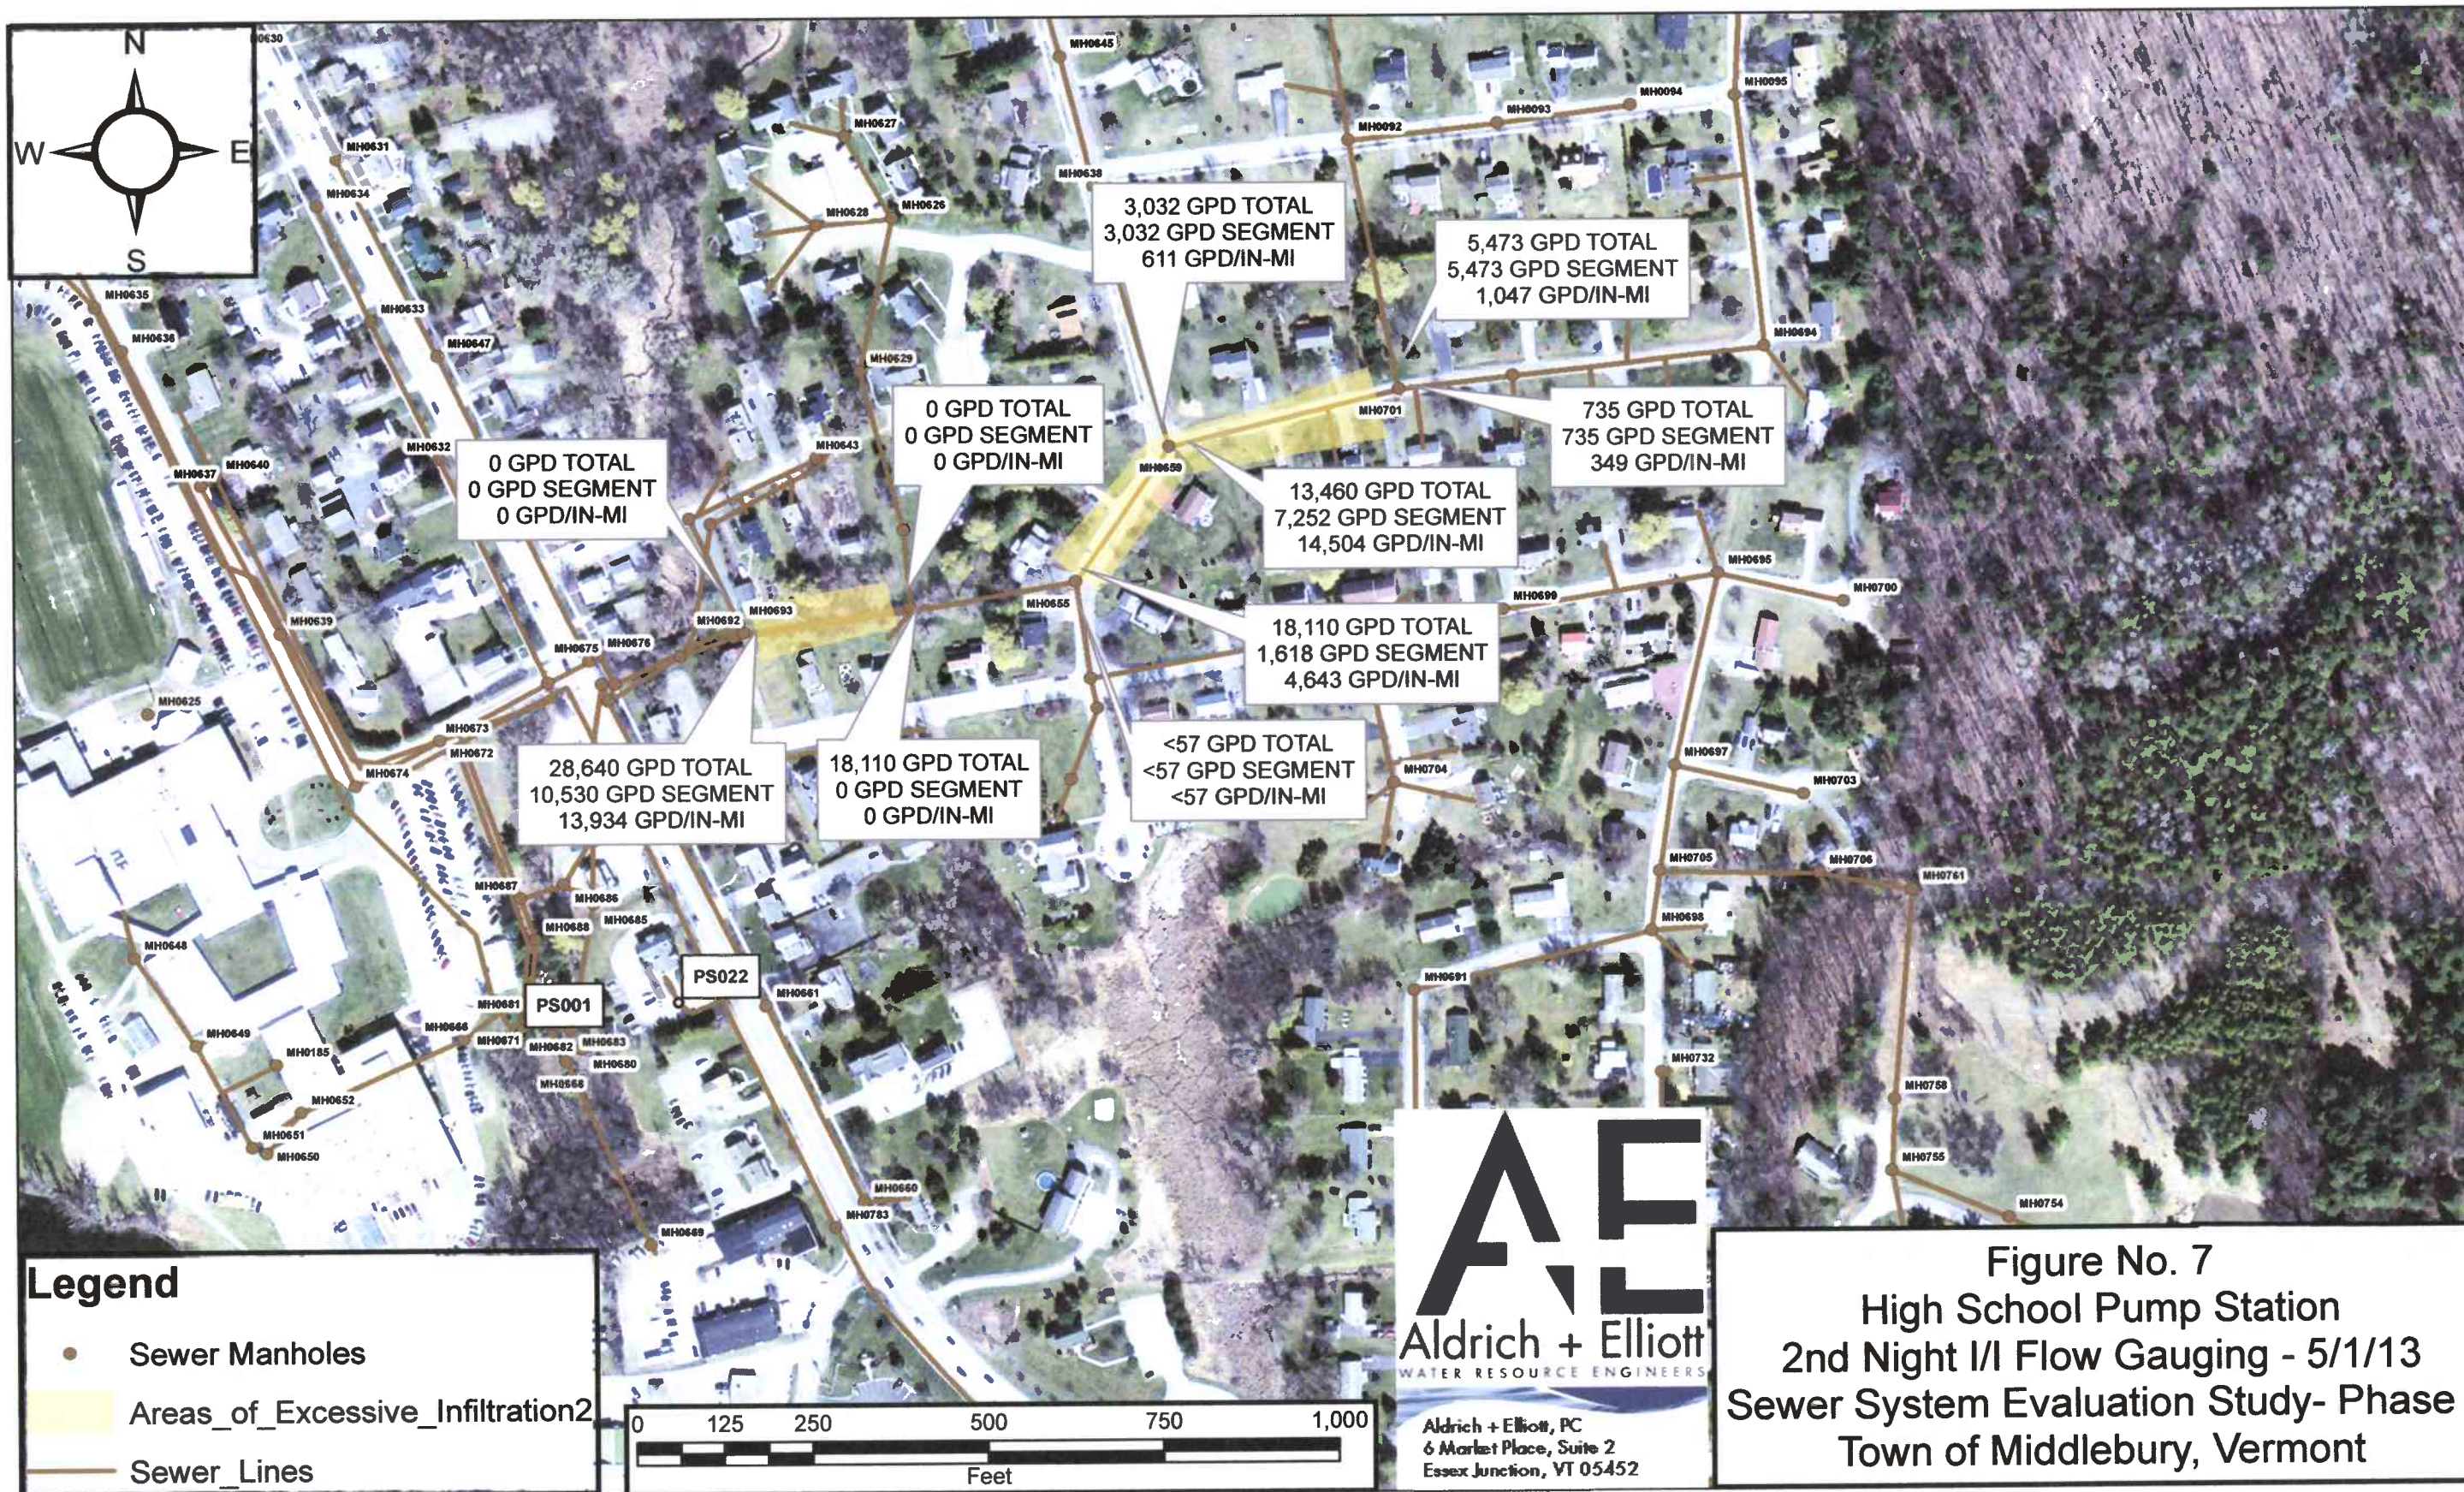
Figure No. 6
Pump Station No. 12
1st Night I/I Flow Gauging- 4/11/13
Sewer System Evaluation Study- Phase I
Town of Middlebury, Vermont

Figure No. 6 provides a map of the gauging locations along with the total measured flow, segment flow and infiltration flow rate. The following is a summary of the flow gauging results:

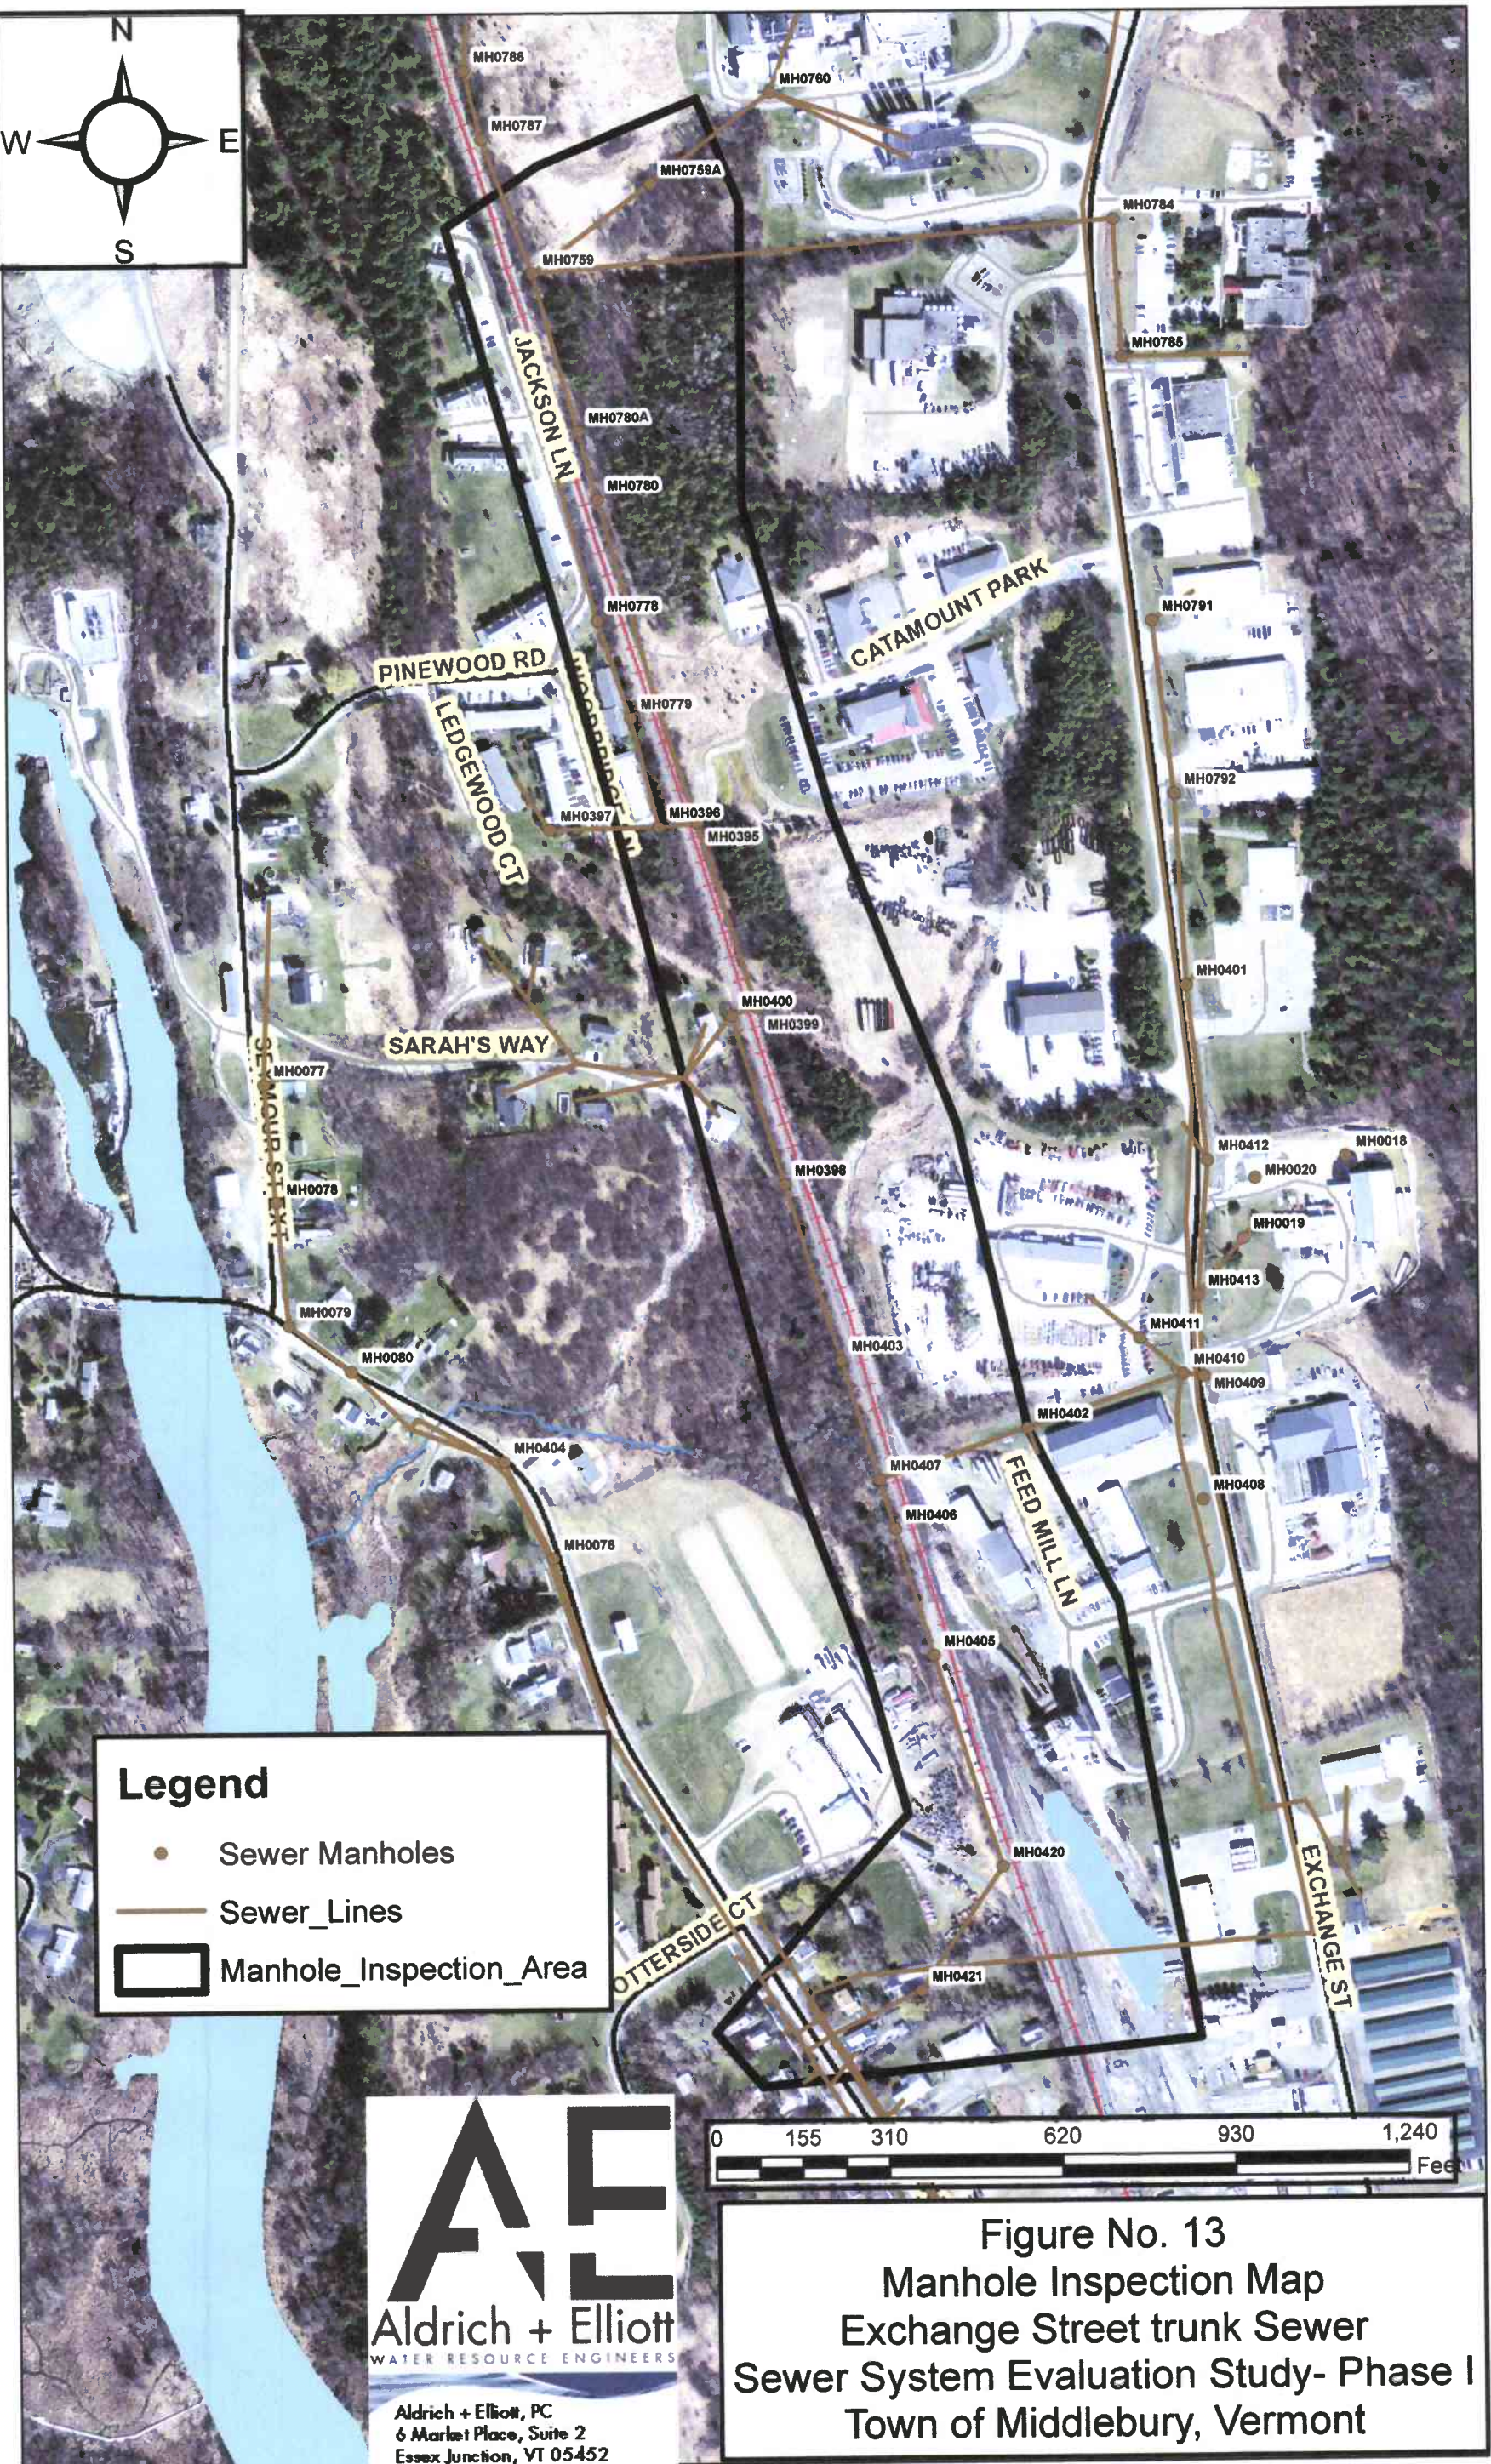
Figure No. 13
Manhole Inspection Map
Exchange Street trunk Sewer
Sewer System Evaluation Study- Phase I
Town of Middlebury, Vermont

Fourteen (14) manhole structures along the Exchange Street trunk sewer were inspected on December 20, 2013. The deficiencies of these manholes included:

- Significant bacterial slime growth on the walls.
- Minor deterioration and spalling of concrete walls.
- Root growth on walls,
- Infiltration in some manholes.

Recommendations for manhole rehabilitation are included in the report.

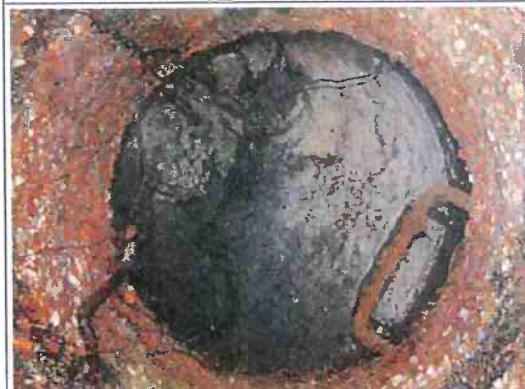
Small 4" cleanout in manhole bottom. Pipe
Encased in concrete. Not good access
For maintenance/cleaning.

Minor deterioration/spalling of concrete walls.

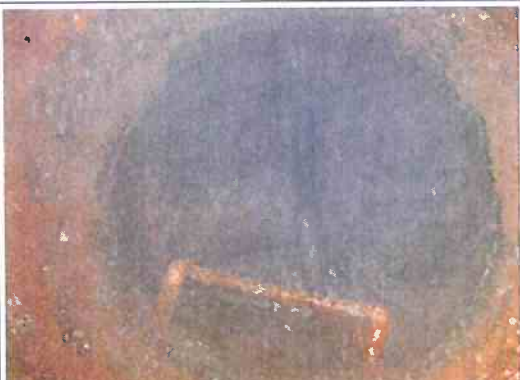
NOTICEABLE DEFICIENCIES: Evidence of Surcharging? Y ☒ N ☐
GRIT? Y ☒ N ☐ Amount: _____ Lift Holes Plugged? Y ☒ N ☐
CLEANLINESS: Y ☒ N ☐ Describe: Grade stakes and rags stuck in pipe. Manhole walls covered in bacterial slime growth.
EXTRANEIOUS WATER? ☒ Y ☐ N Quantity: Weeps Location: MH riser joints.
CRACKS? ☒ Y ☐ N Describe: Around MH riser joints.

OTHER COMMENTS AND REMARKS:	DIAGRAM: (Show location & size of all inlets and outlets)
Minor roots on walls. Minor deterioration and spalling of concrete walls.	Describe:
Inlet slip line pipe push too far into manhole causing flow restriction.

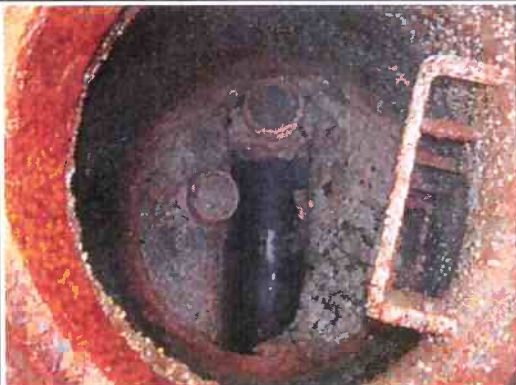
OTHER COMMENTS AND REMARKS:
Small 4" cleanout in manhole bottom. Valve does not work. Not good access for maintenance/cleaning.

Minor deterioration/spalling of concrete walls.

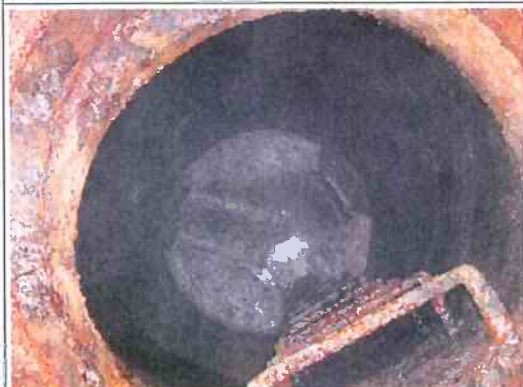
OTHER COMMENTS AND REMARKS:
Outlet 14" PE pipe pushed in too far causing Restriction of flow.

Minor deterioration/spalling of concrete walls.

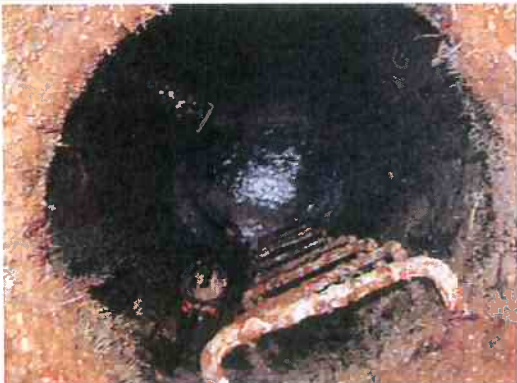
Outlet 14" PE pipe pushed in too far causing Restriction of flow.

Minor deterioration/spalling of concrete walls and roots.

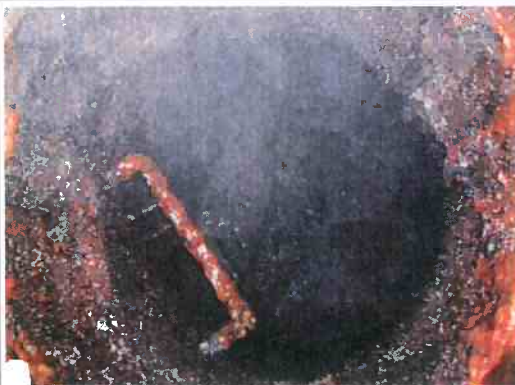
NOTICEABLE DEFICIENCIES: Evidence of Surcharging? (Y) N
GRIT? (Y) N Amount: invert 1/2 full Lift Holes Plugged? (Y) N
CLEANLINESS: Y (N) Describe: Entire manhole wall has significant slime growth. Minor spalling of concrete walls
EXTRANEIOUS WATER? Y (N) Quantity: _____ Location: _____
CRACKS? Y (N) Describe: _____

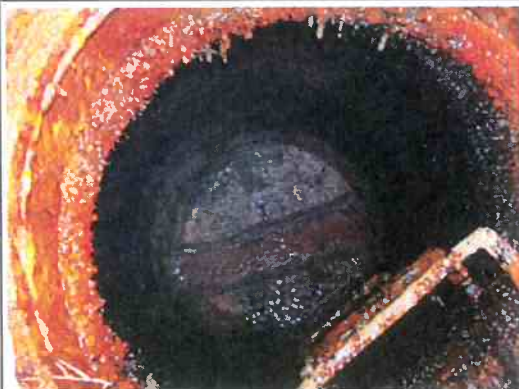
NOTICEABLE DEFICIENCIES: Evidence of Surcharging? ☒ Y N
GRIT? Y ☒ N Amount: _____ Lift Holes Plugged? ☒ Y N
CLEANLINESS: ☒ Y N Describe: Manhole walls covered in bacterial slime growth.
EXTRANEIOUS WATER? ☒ Y N Quantity: Weeping Location: At both pipe connections and base/riser joint.
CRACKS? ☒ Y N Describe:

OTHER COMMENTS AND REMARKS:
Inlet pipe leaking between 12" PE slipline and 14" original pipe.

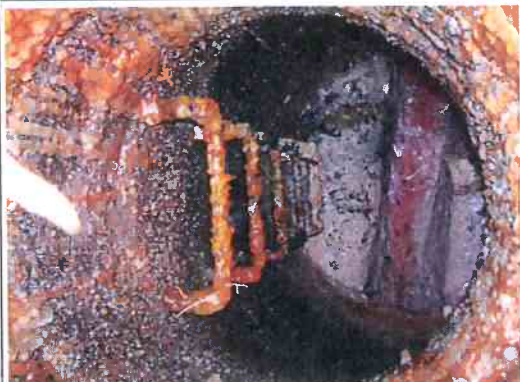
NOTICEABLE DEFICIENCIES: Evidence of Surcharging? Y ☒ N
GRIT? Y ☒ N Amount: _____ Lift Holes Plugged? ☒ Y N
CLEANLINESS: ☒ Y N Describe: Manhole walls covered in bacterial slime growth.
EXTRANEIOUS WATER? ☒ Y N Quantity: 5 gpm Location: Hole in MH Wall and under frame.
CRACKS? ☒ Y N Describe: Hole in MH Wall.
